RE: **Docket No. 20-035-01**
Application to Increase the Deferred Rate through the Energy Balancing Account
Mechanism
Rocky Mountain Power Response Testimony

Response Testimony of David G. Webb

Response Testimony of Dana M. Ralston

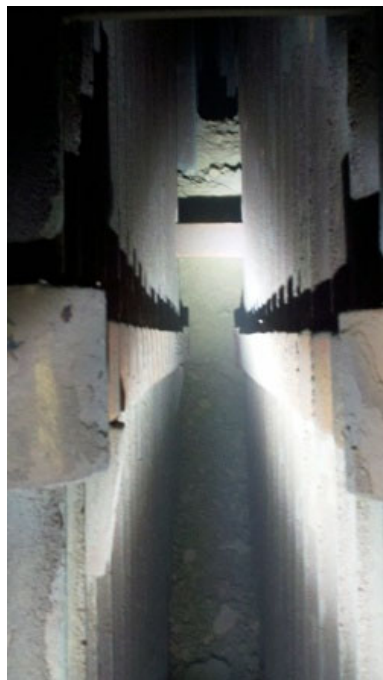
Vertical RH Assemblies:

No tubes were found with thicknesses below 80% of min wall thickness. The ash build up in the area made it difficult to inspect, but it was not more than typically build up in the area. Thickness measurements will be added to Unit 3 spreadsheet to track erosion rates.

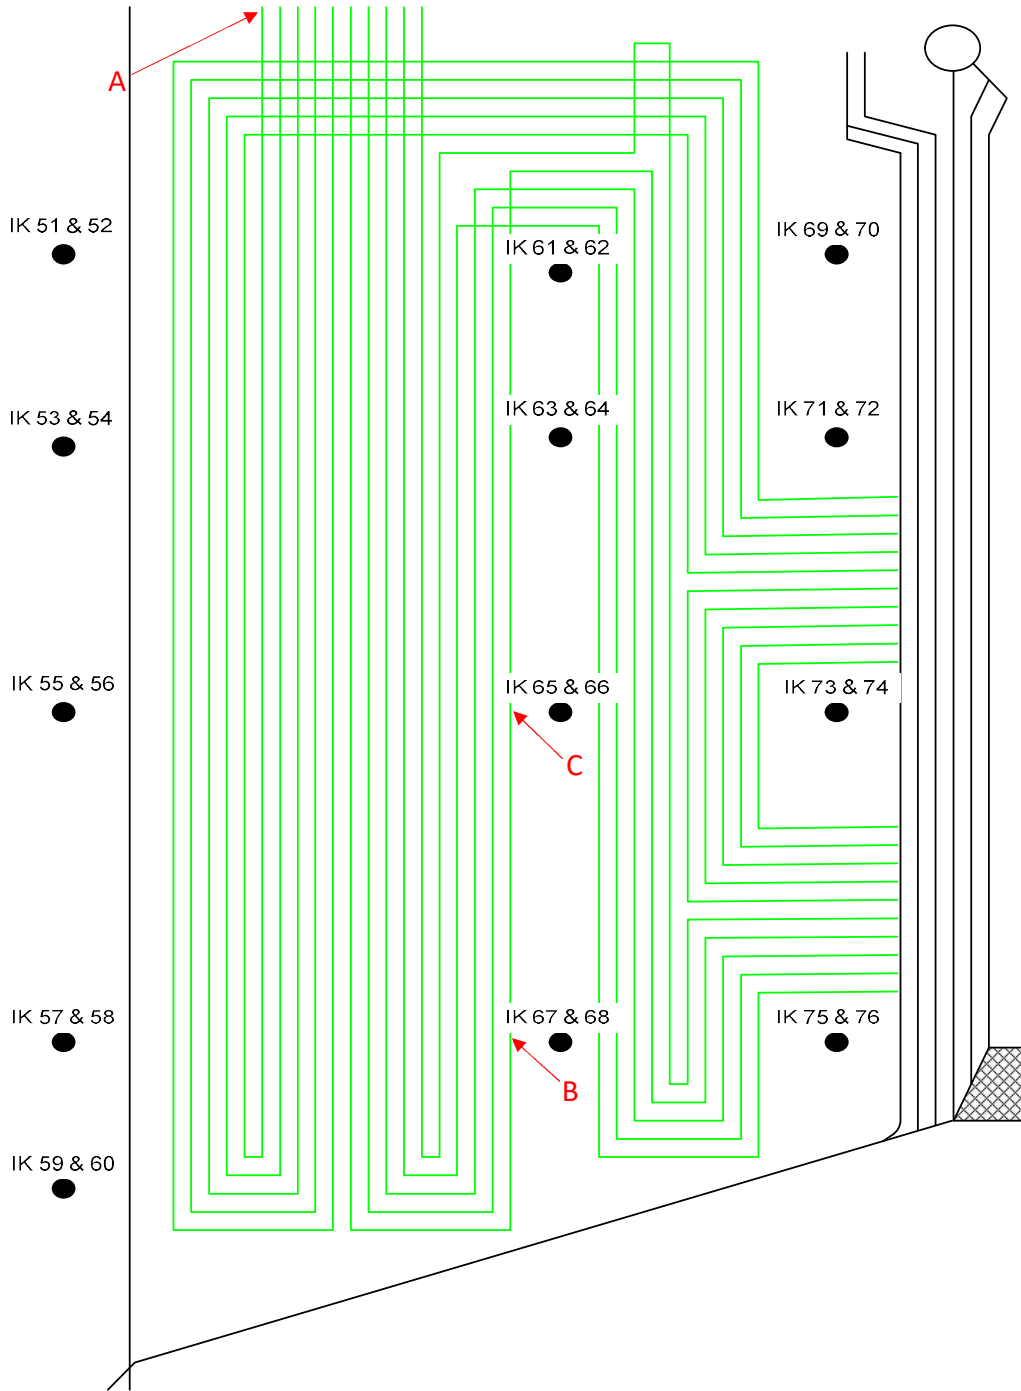
VERTICAL REHEATER UT DATA

Priority A, B, C	ASSY	TUBE Position	LOCATION WORK REQUIRED	DATE W/C	VERIFIED WELDER ID	VISUAL
A	8	C1	Replace 5' eroded tube section as marked.			
A	27	C1	Replace 5' eroded tube section as marked.			
A	29	C1	Replace 5' eroded tube section as marked.			
A	35	C1	Replace 5' eroded tube section as marked.			
A	37	C1	Replace 5' eroded tube section as marked.			
A	39	C1	Replace 5' eroded tube section as marked.			
A	40	C1	Replace 5' eroded tube section as marked.			
A	45	C1	Replace 5' eroded tube section as marked.			
A	47	C1	Replace 5' eroded tube section as marked.			
A	48	C1	Replace 5' eroded tube section as marked.			
A	49	C1	Replace 5' eroded tube section as marked.			
A	50	C1	Replace 5' eroded tube section as marked.			
A	51	C1	Replace 5' eroded tube section as marked.			
A	53	C1	Replace 5' eroded tube section as marked.			
A	54	C1	Replace 5' eroded tube section as marked.			
A	55	C1	Replace 5' eroded tube section as marked.

A	56	C1	Replace 5' eroded tube section as marked.			
A	57	C1	Replace 5' eroded tube section as marked.			
A	59	C1	Replace 5' eroded tube section as marked.			
A	61	C1	Replace 5' eroded tube section as marked.			
A	64	C1	Replace 5' eroded tube section as marked.			
A	65	C1	Replace 5' eroded tube section as marked.			
A	66	C1	Replace 5' eroded tube section as marked.			
A	67	C1	Replace 5' eroded tube section as marked.			
A	68	C1	Replace 5' eroded tube section as marked.			
			AS VIEWED FROM IK'S 67 & 68			
B			Repair refractory around the man way openings on both the left and right side walls.			
			AS VIEWED FROM TOP SCAFFOLD DECK AT THE ROOF (REAR SIDE OF FRONT PANELS)			
			No repair items noted.			
			AS VIEWED FROM IK'S 61 & 62 (REAR PANELS)			
B	10	5-6,10-11	Reposition disengaged alignment bracket as marked.

Priority A, B, C	ASSY	TUBE Position	LOCATION WORK REQUIRED	DATE W/C	VERIFIED	WELDER ID	VISUAL
B	14	5-6	Reposition disengaged alignment bracket as marked.				
B	22	9-10	Reposition disengaged alignment bracket as marked.				
B	42	9-10	Reposition disengaged alignment bracket as marked.				
B	48	9-10	Reposition disengaged alignment bracket as marked.				
B	56	9-10	Reposition disengaged alignment bracket as marked.				
B	58	9-10	Reposition disengaged alignment bracket as marked.				
B	60	8-9	Reposition disengaged alignment bracket as marked.				
B	62	4-5	Reposition disengaged alignment bracket as marked.				
B	64	9-10	Reposition disengaged alignment bracket as marked.				
B	68	5-9	Reposition disengaged alignment bracket as marked.				
			TOTALS:				
			30 TUBE REPLACEMENTS				
			72 SHIELD ADDITIONS				
			21 REPAIR ALIGNMENT BRACKETS
